THE UNIVERSITY of EDINBURGH  
Estates Department

**Old College**  
Stonework Repairs to External Facades

**September 2019**

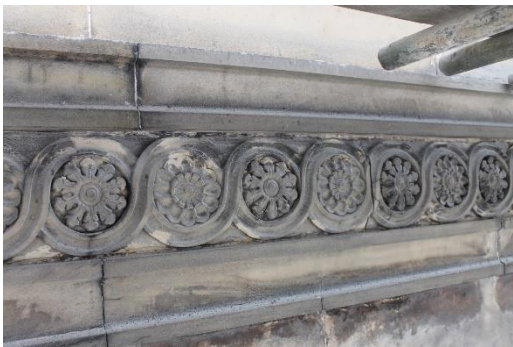
*Section of cleaned decorative moulding*

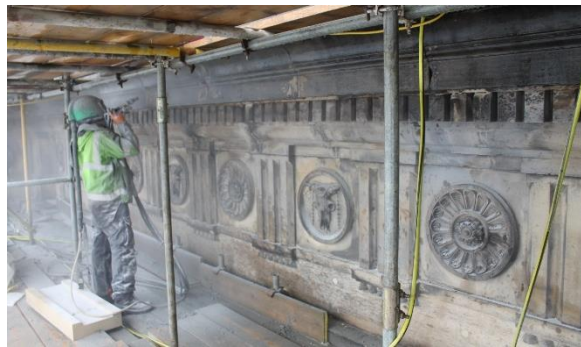
*Low pressure soft abrasive cleaning*

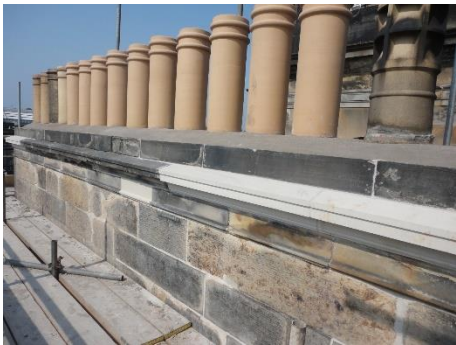
*Stonework repairs to deteriorated chimney*

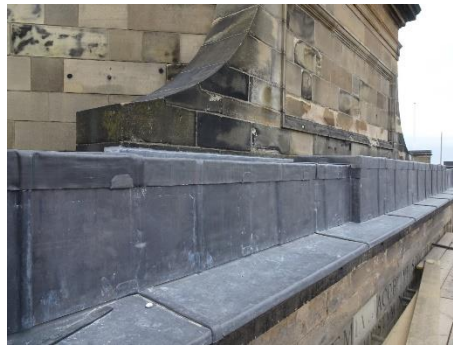
*New lead upstand flashings*

- Sections of cornice delaminating due to weather erosion
- Deterioration of stone due to water penetration
- Failed lead perimeter flashings allowing water to leak through cornice causing stone decay
- New lead perimeter gutters and edge upstand flashings

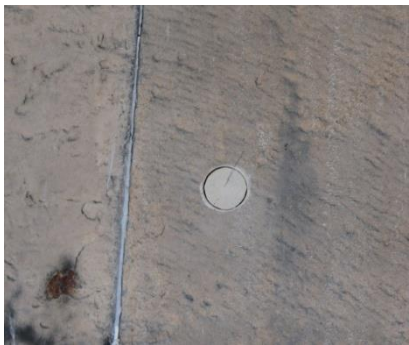
*Insertion of stone plugs*

- New lead cornice flashings and replacement of damaged stone in and below cornice
- Stitching repairs to cracked window head to stabilise and avoid replacement
- Stonework repairs to deteriorated chimney
- Stone “plugs” cut from the original stone were used to fill holes cut for scaffold ties on historic repair schemes
- Stone cleaning using low pressure soft abrasive cleaning of heavily soiled areas, as approved by Edinburgh City Council after cleaning trials. Most of flat surfaces cleaned by steam and biocide with the abrasive cleaning confined to heavily soiled areas
- Bird protection spikes being fitted to ledges and projections.

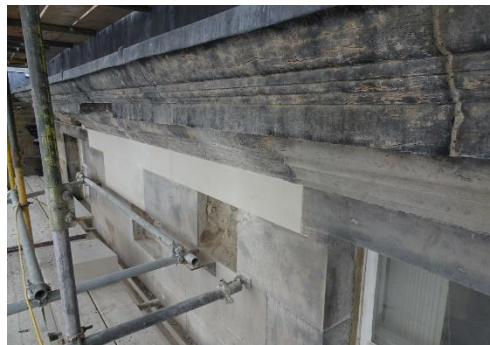
*New lead cornice flashings and replacement stone*
